# **Air France Flight AF 447**

over the Atlantic ocean on June 1, 2009

Based on France's BEA's Final Report of this accident,  
with my personal observations and comments.

OLLI Course T 802

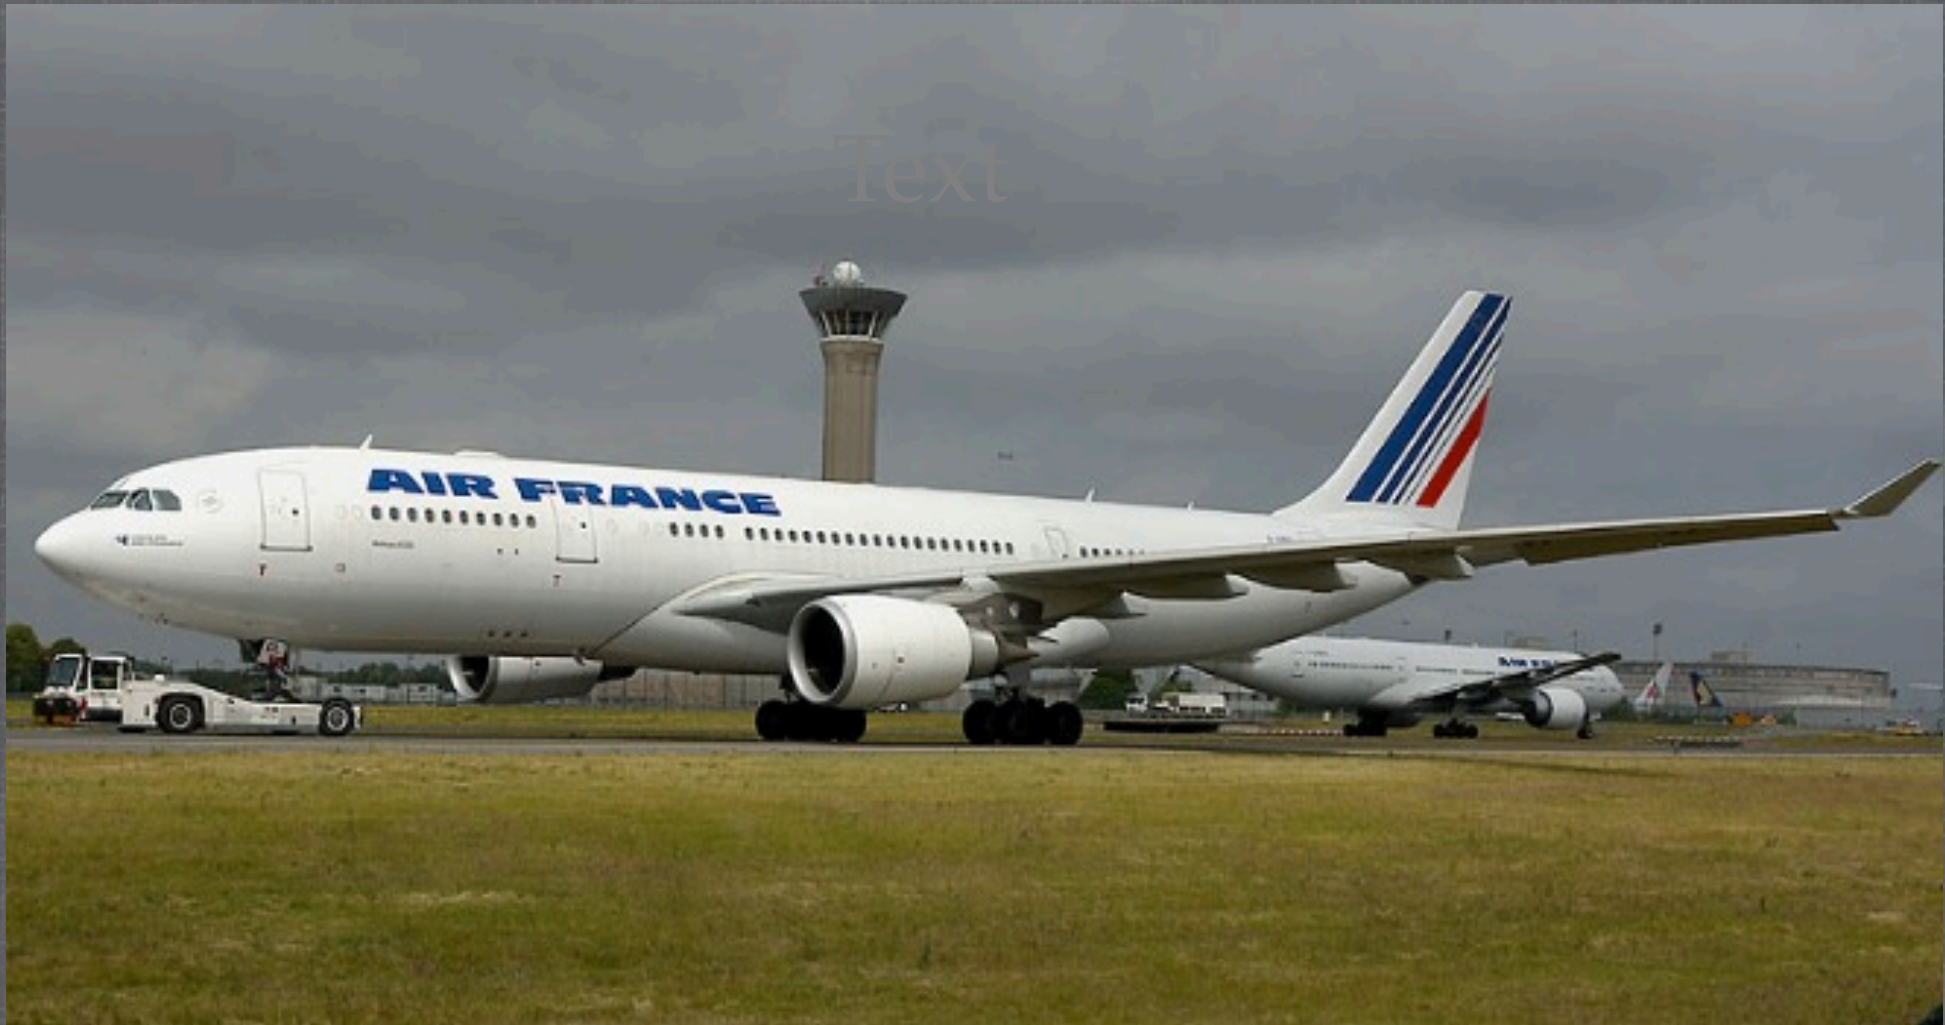
- Airbus A-330-200, operated by Air France
- Built in 2005 , Toulouse, France
- 18,870 hours flying time (block to block)
- cost (list price) =~ € 195 million

This is the aircraft involved

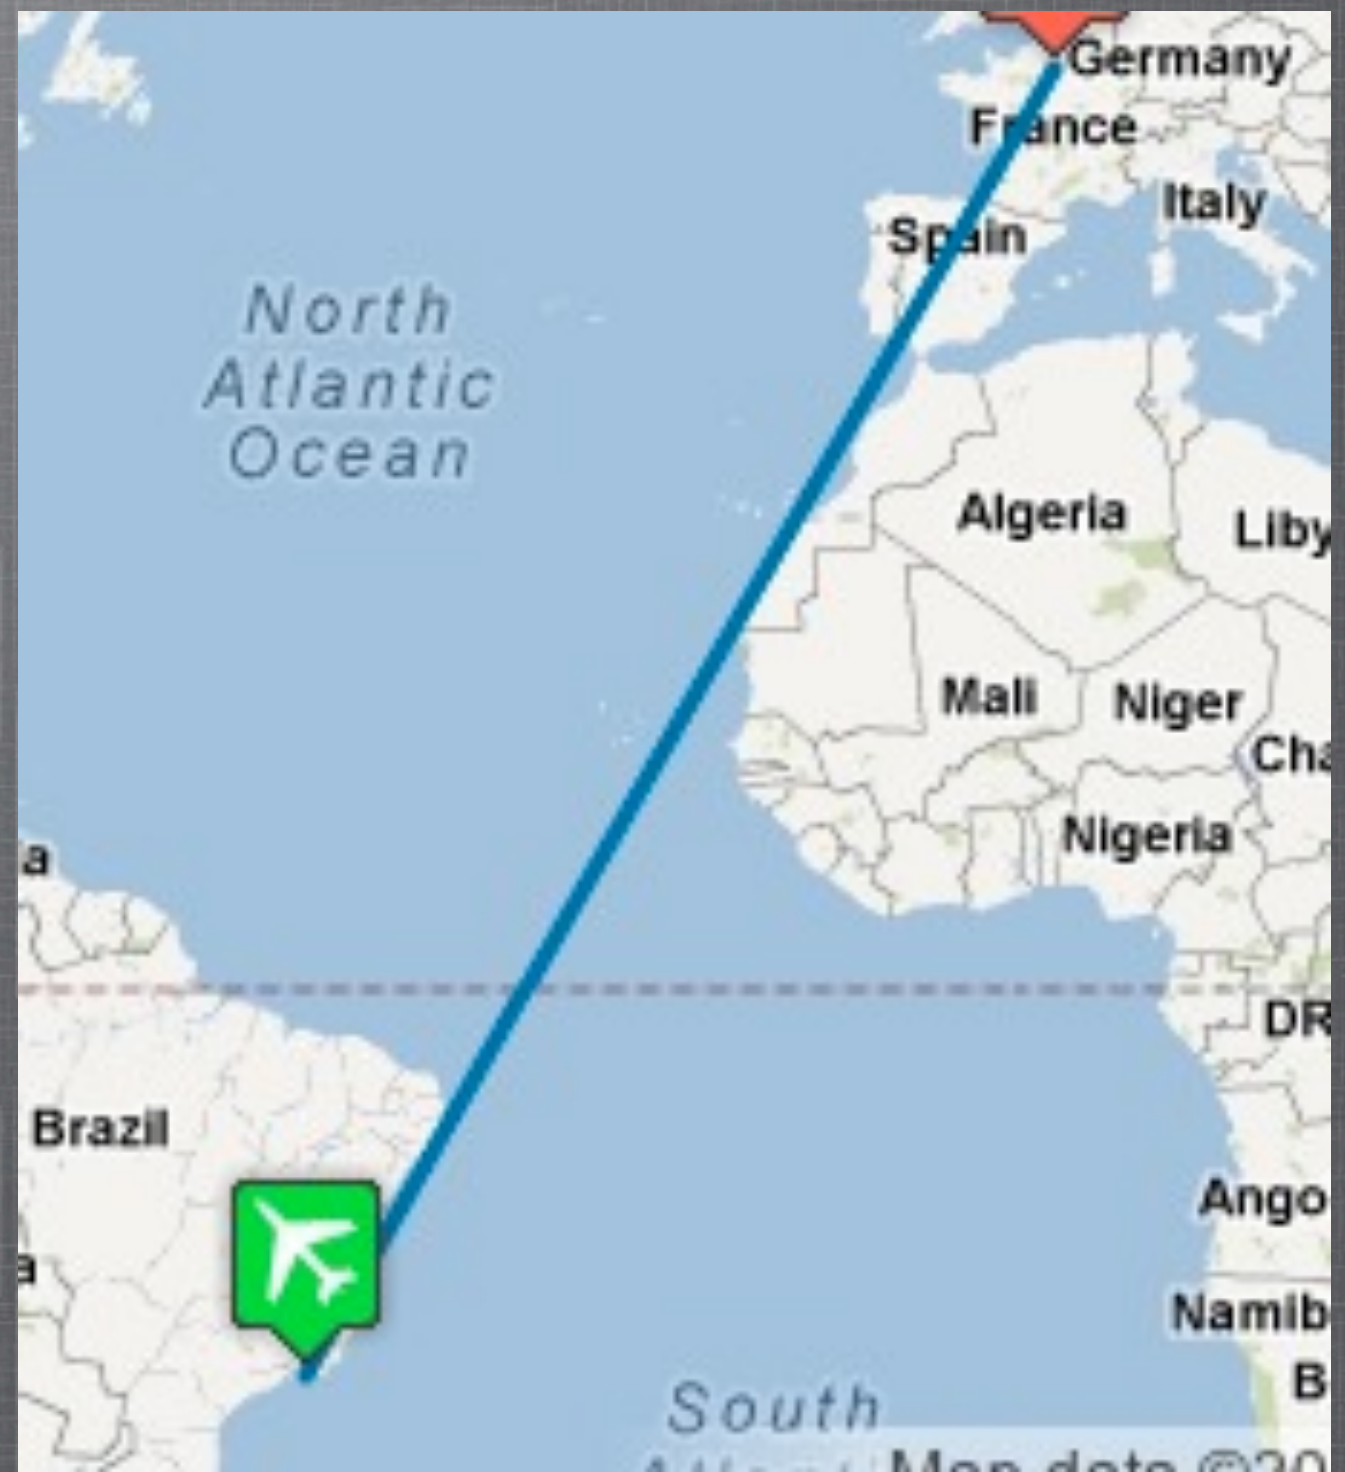
Flight AF 447 was under radar control from departure from Rio de Janeiro airport to the INTOL waypoint, and under radar coverage up to the SALPU waypoint (RECIFE FIR, located between INTOL and ORARO). After this point, AF 447 was under en-route control (via a flight progress strip) based on information in the flight plan updated by the crew or by exchanges between control centres.

Air Traffic  
control  
route for  
flight and  
ATC  
control  
sectors

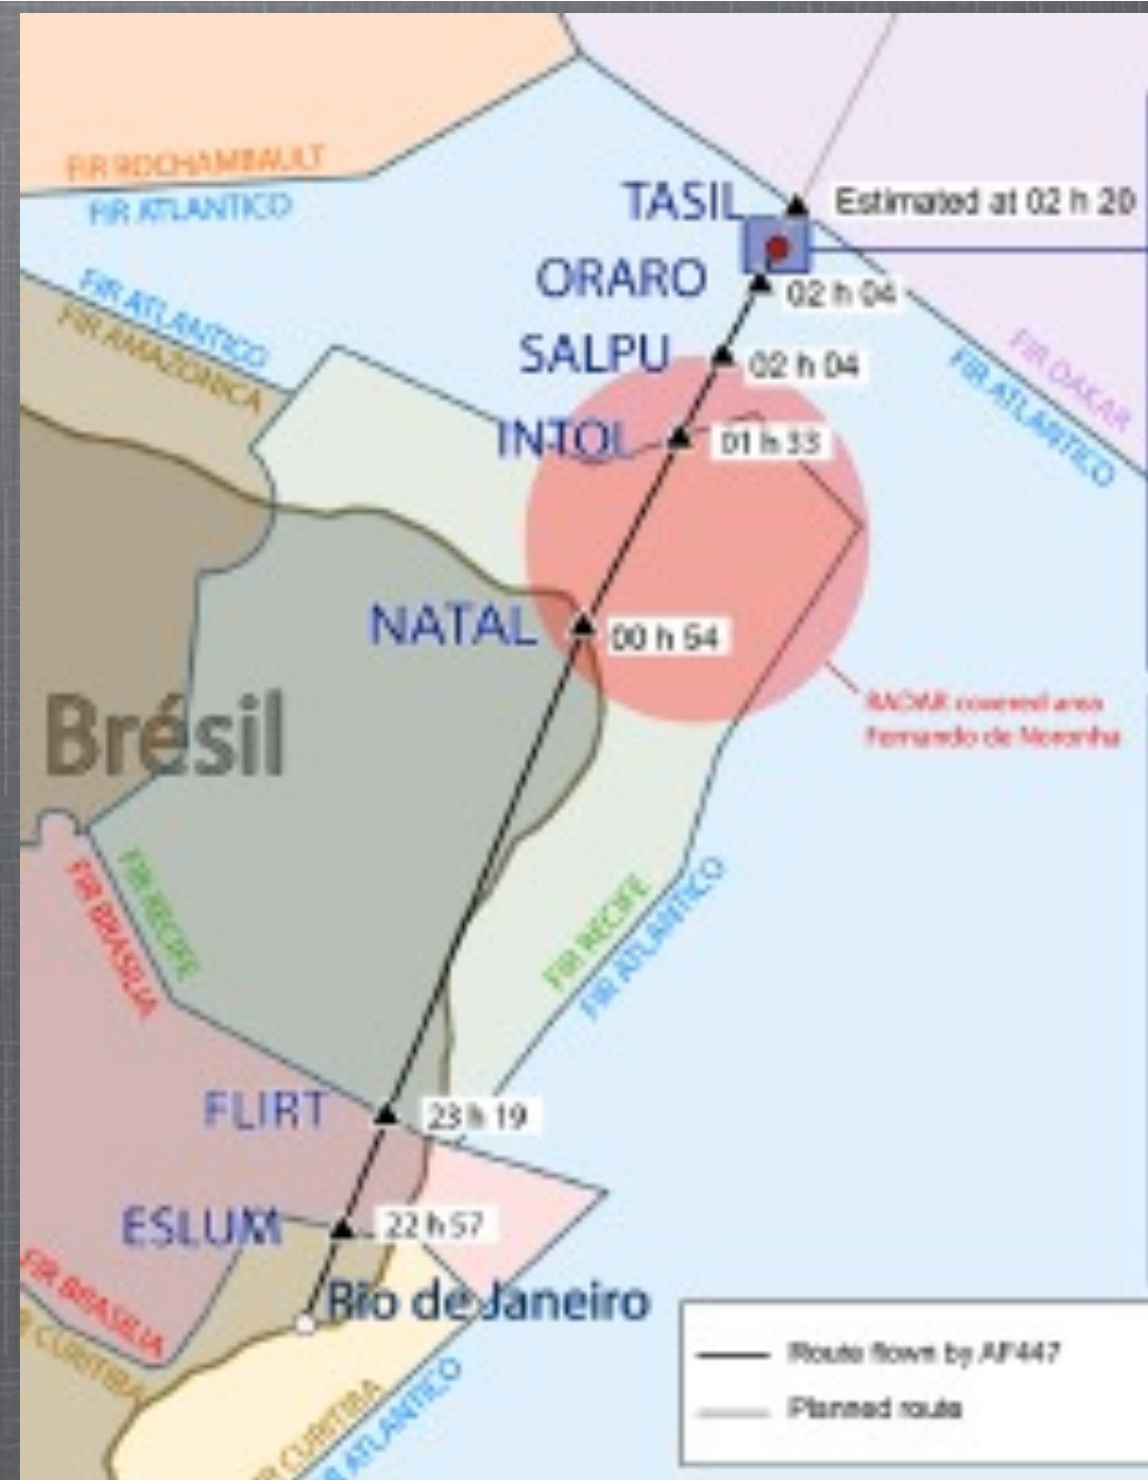
447 left Brazil coastline at NATAL waypoint about 01:00 under radar control. After that it was tracked by radar in the Recife Flight Information Region (FIR) until SALPU waypoint. Then flight was out of radar range, with position updates dependent on radio communications between 447 and ATC center in Senegal Africa

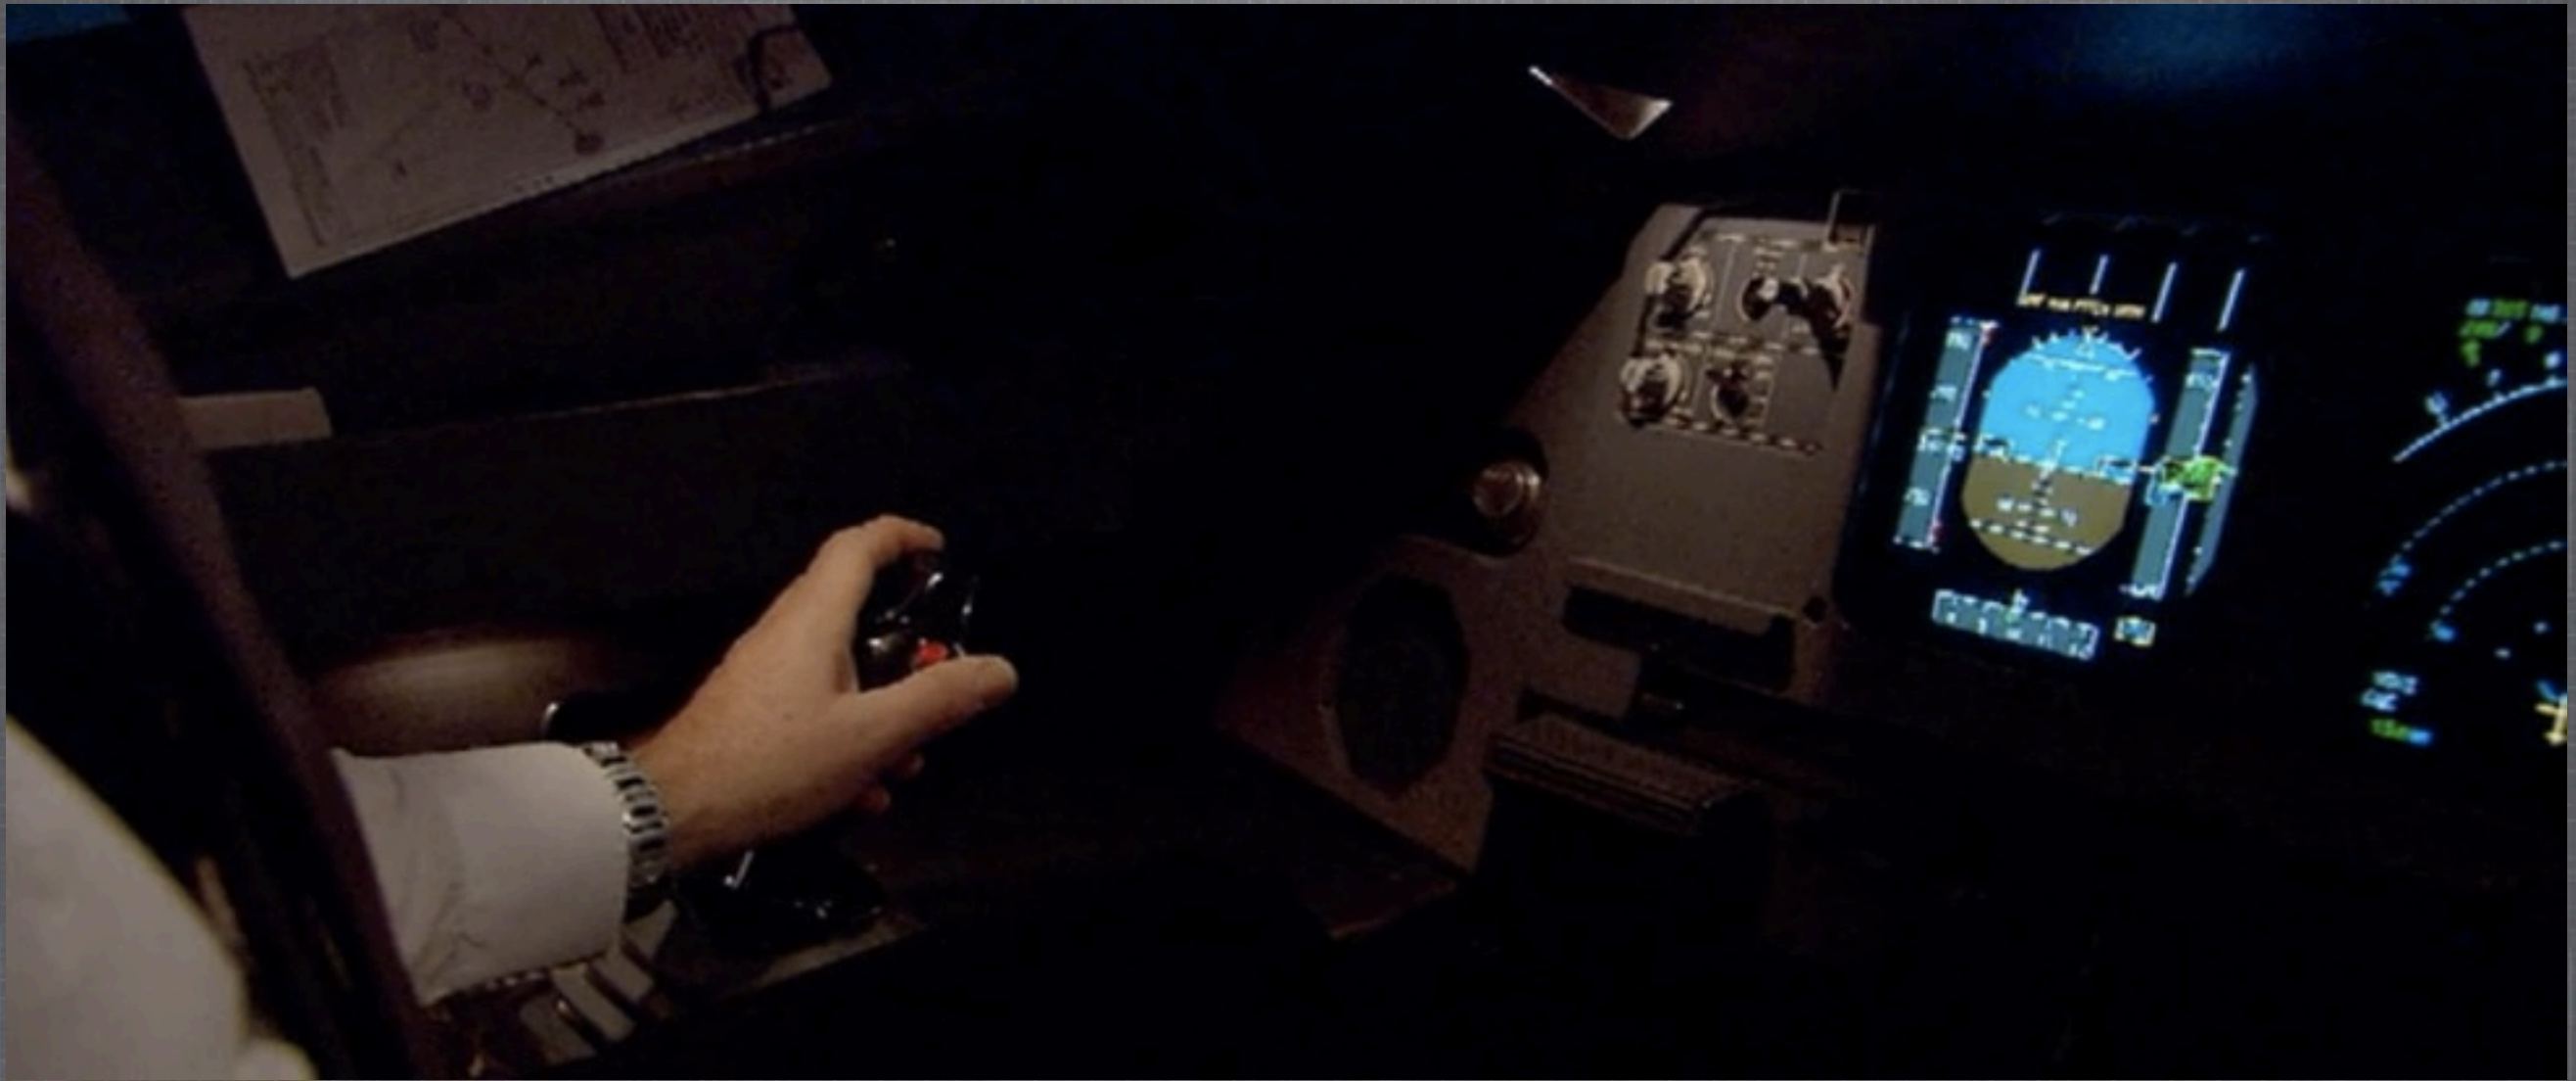
# A330 cockpit at night

Aircraft was being operated from cockpit by two Pilots (PF and PNF)  
Dark outside until accident. Flying on instruments – no visual cues  
Note joystick– A330 is a “fly by wire” designed aircraft, highly computerized to achieve normal flights.

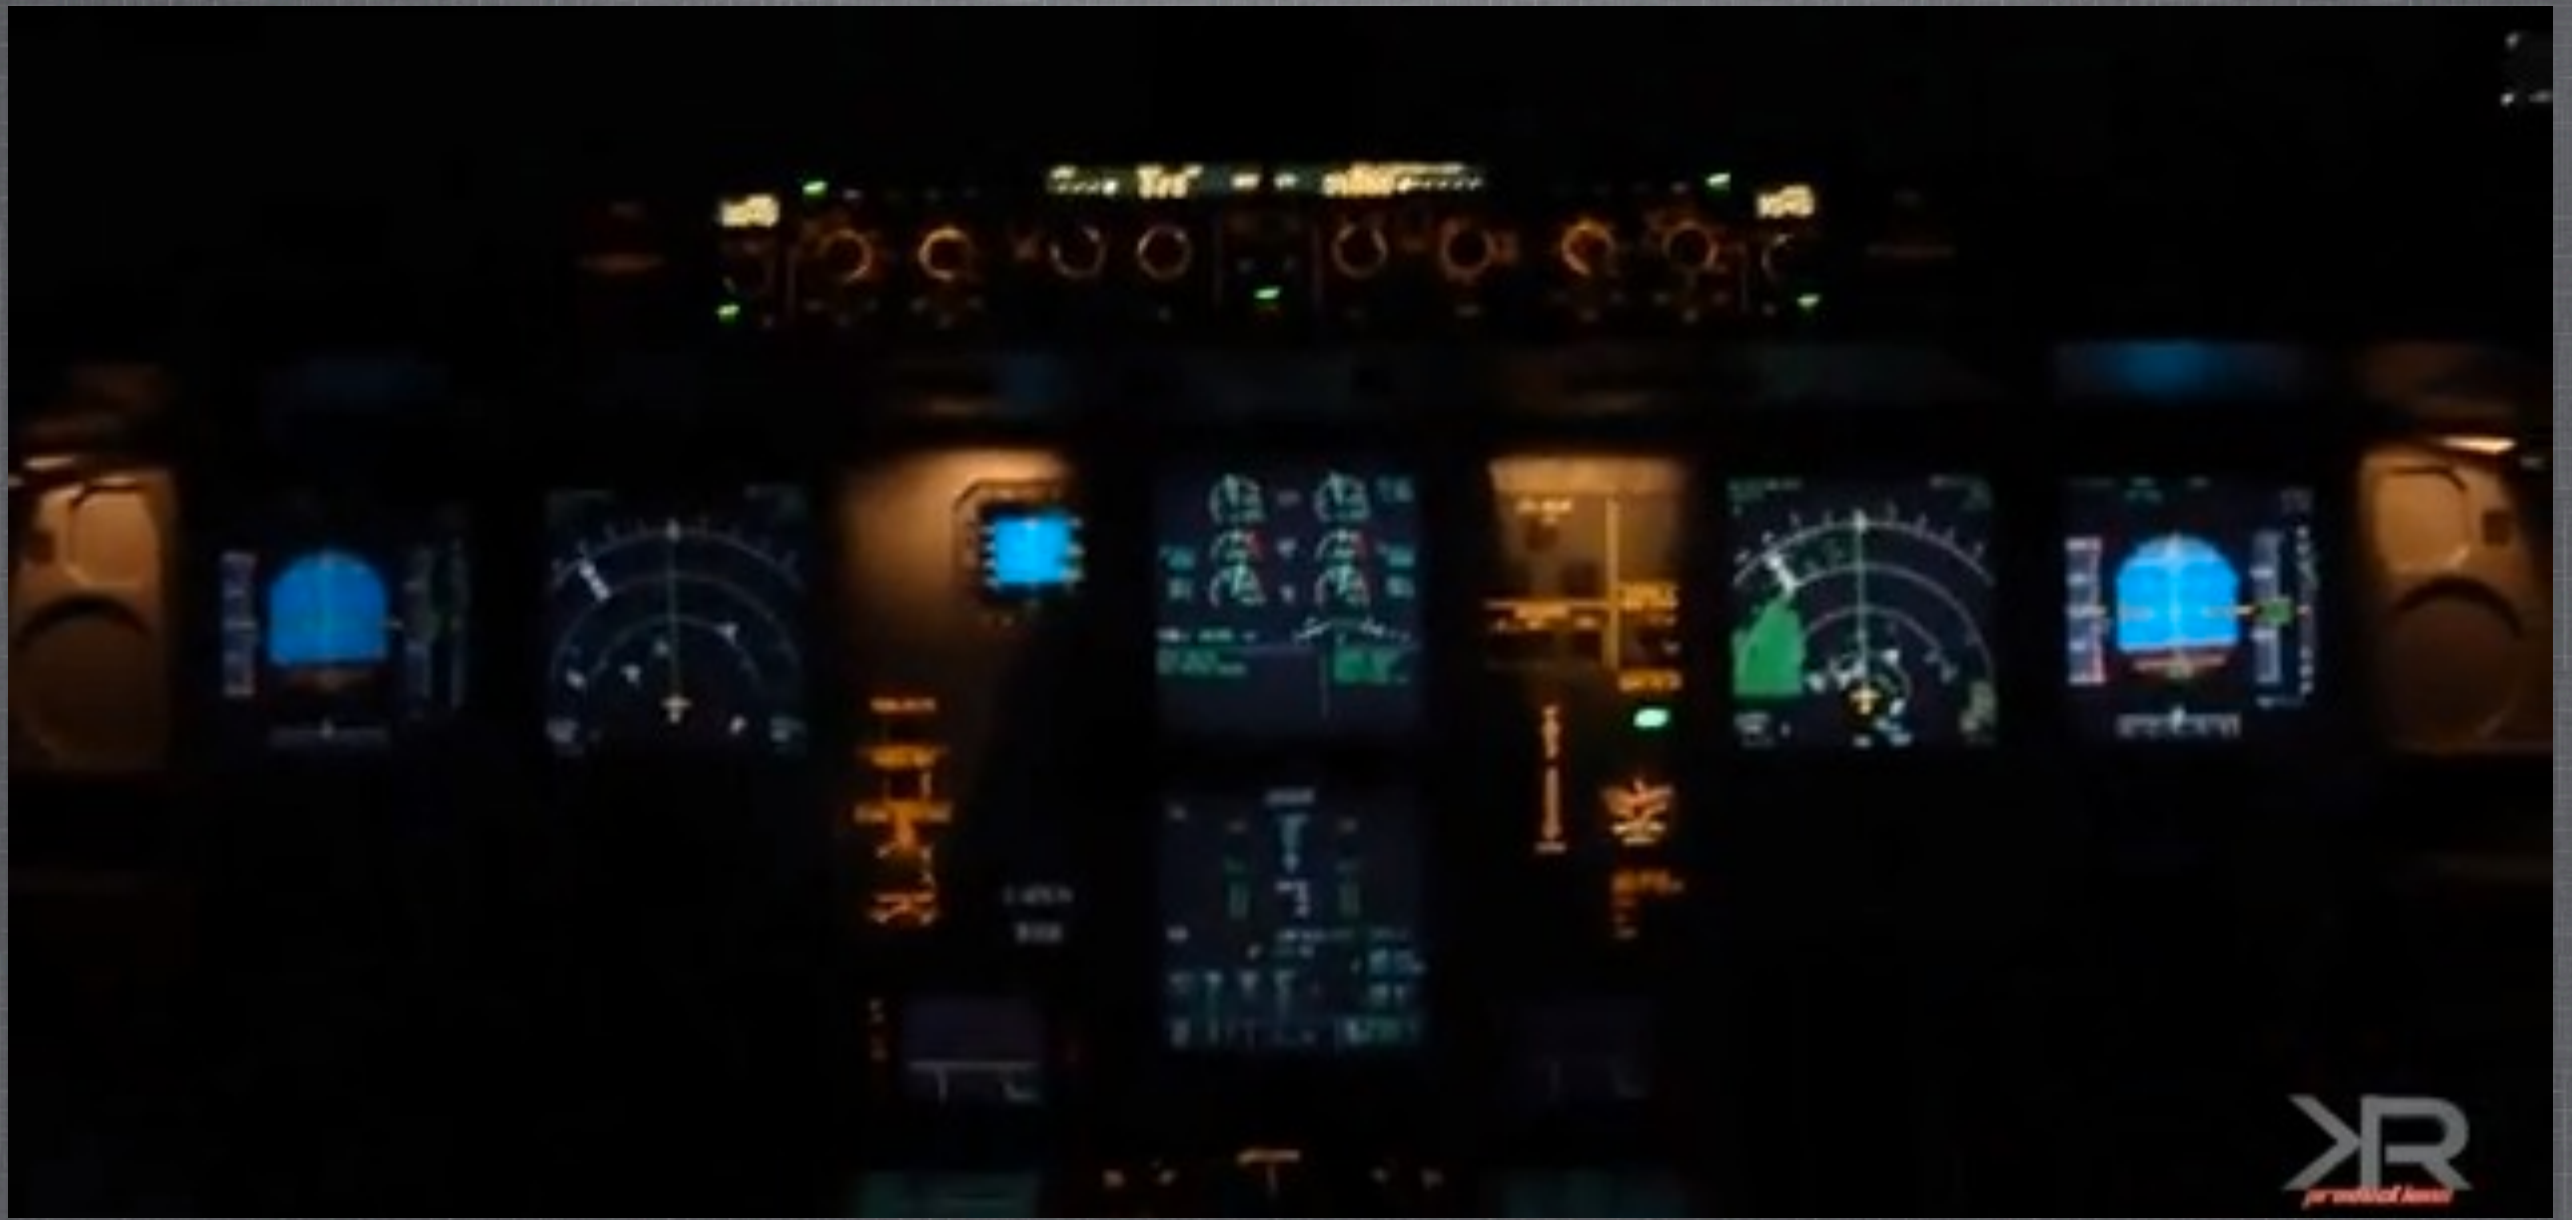
# A330 cockpit at night

This shows displays in cockpit on which pilots relied for information about their flight.

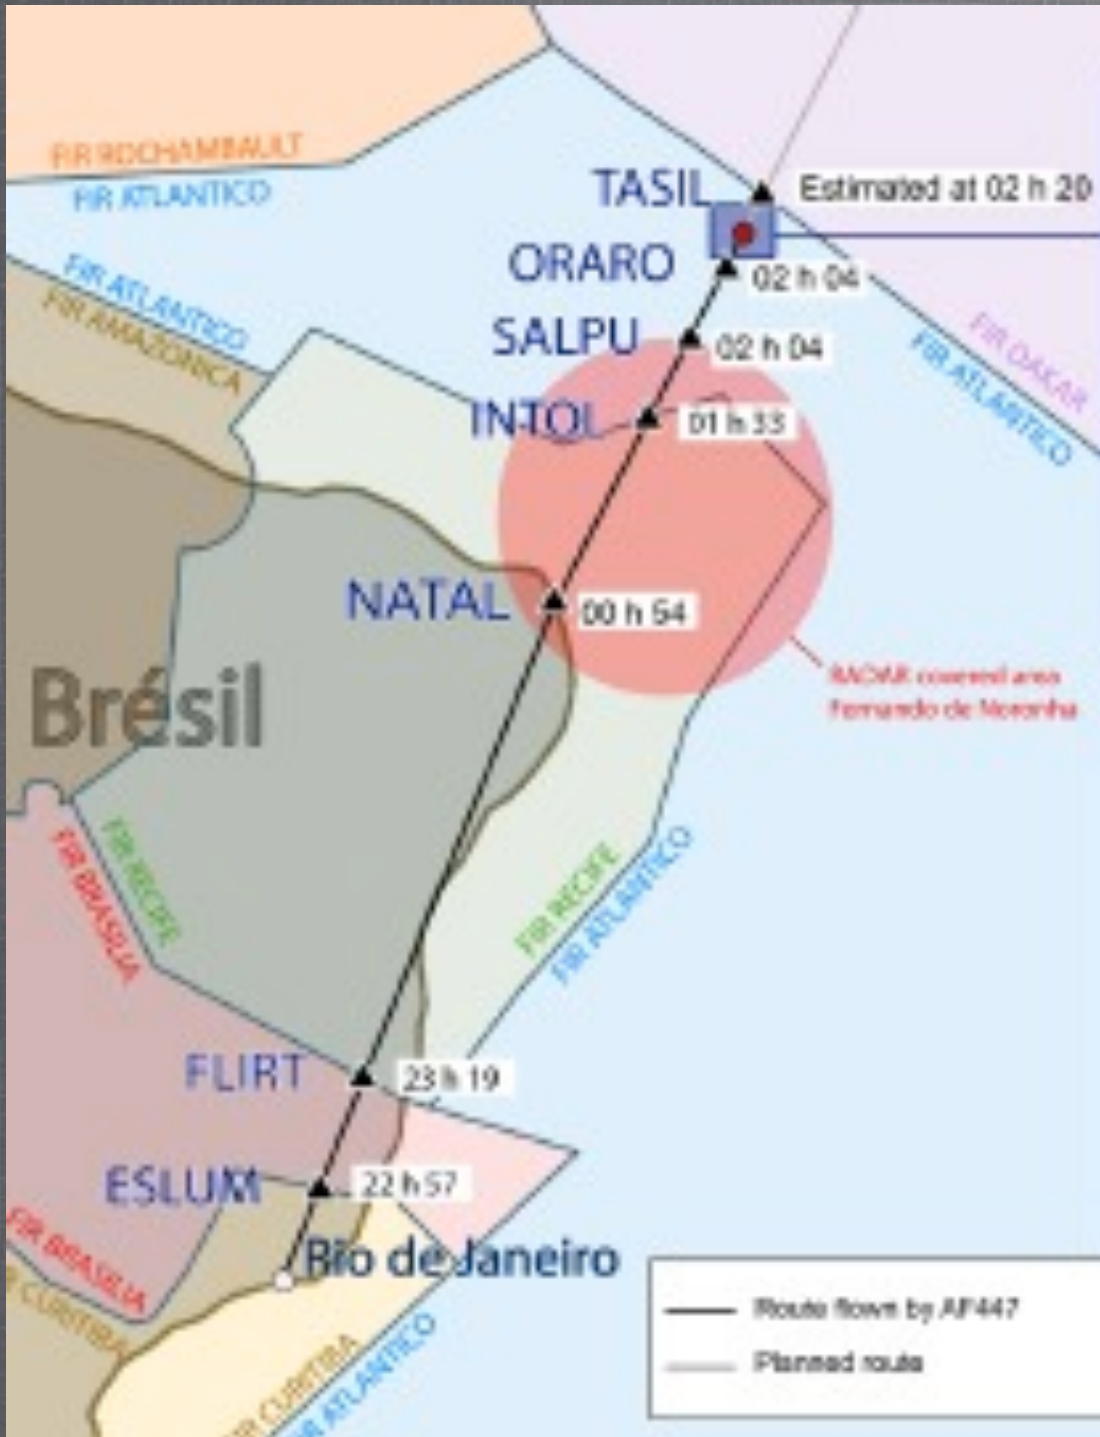
# Flight history...

- Uneventful flight at FL35 on autopilot to INTOL
- At INTOL, attempt to switch to Dakar Oceanic failed (1:35)
- Crew noted “thing ahead” on radar (1:35 +?)
- Flew into slightly turbulent zone at SALPU (1:45)
- Turbulence stopped (1:52)
- Approached ORARO at FL35, MACH .82, pitch  $\sim 2.5^\circ$ , w&b=205 tonnes and  $29^\circ$ , couldn't climb above cloud layer
- PF advised cabin crew to watch out in 2 min (2:08)

Note perturbation for 7 minutes between SALPU and ORARO waypoints.  
Note also the slight pitch angle at which plane was stable at altitude. Probably unnoticeable in cabin.

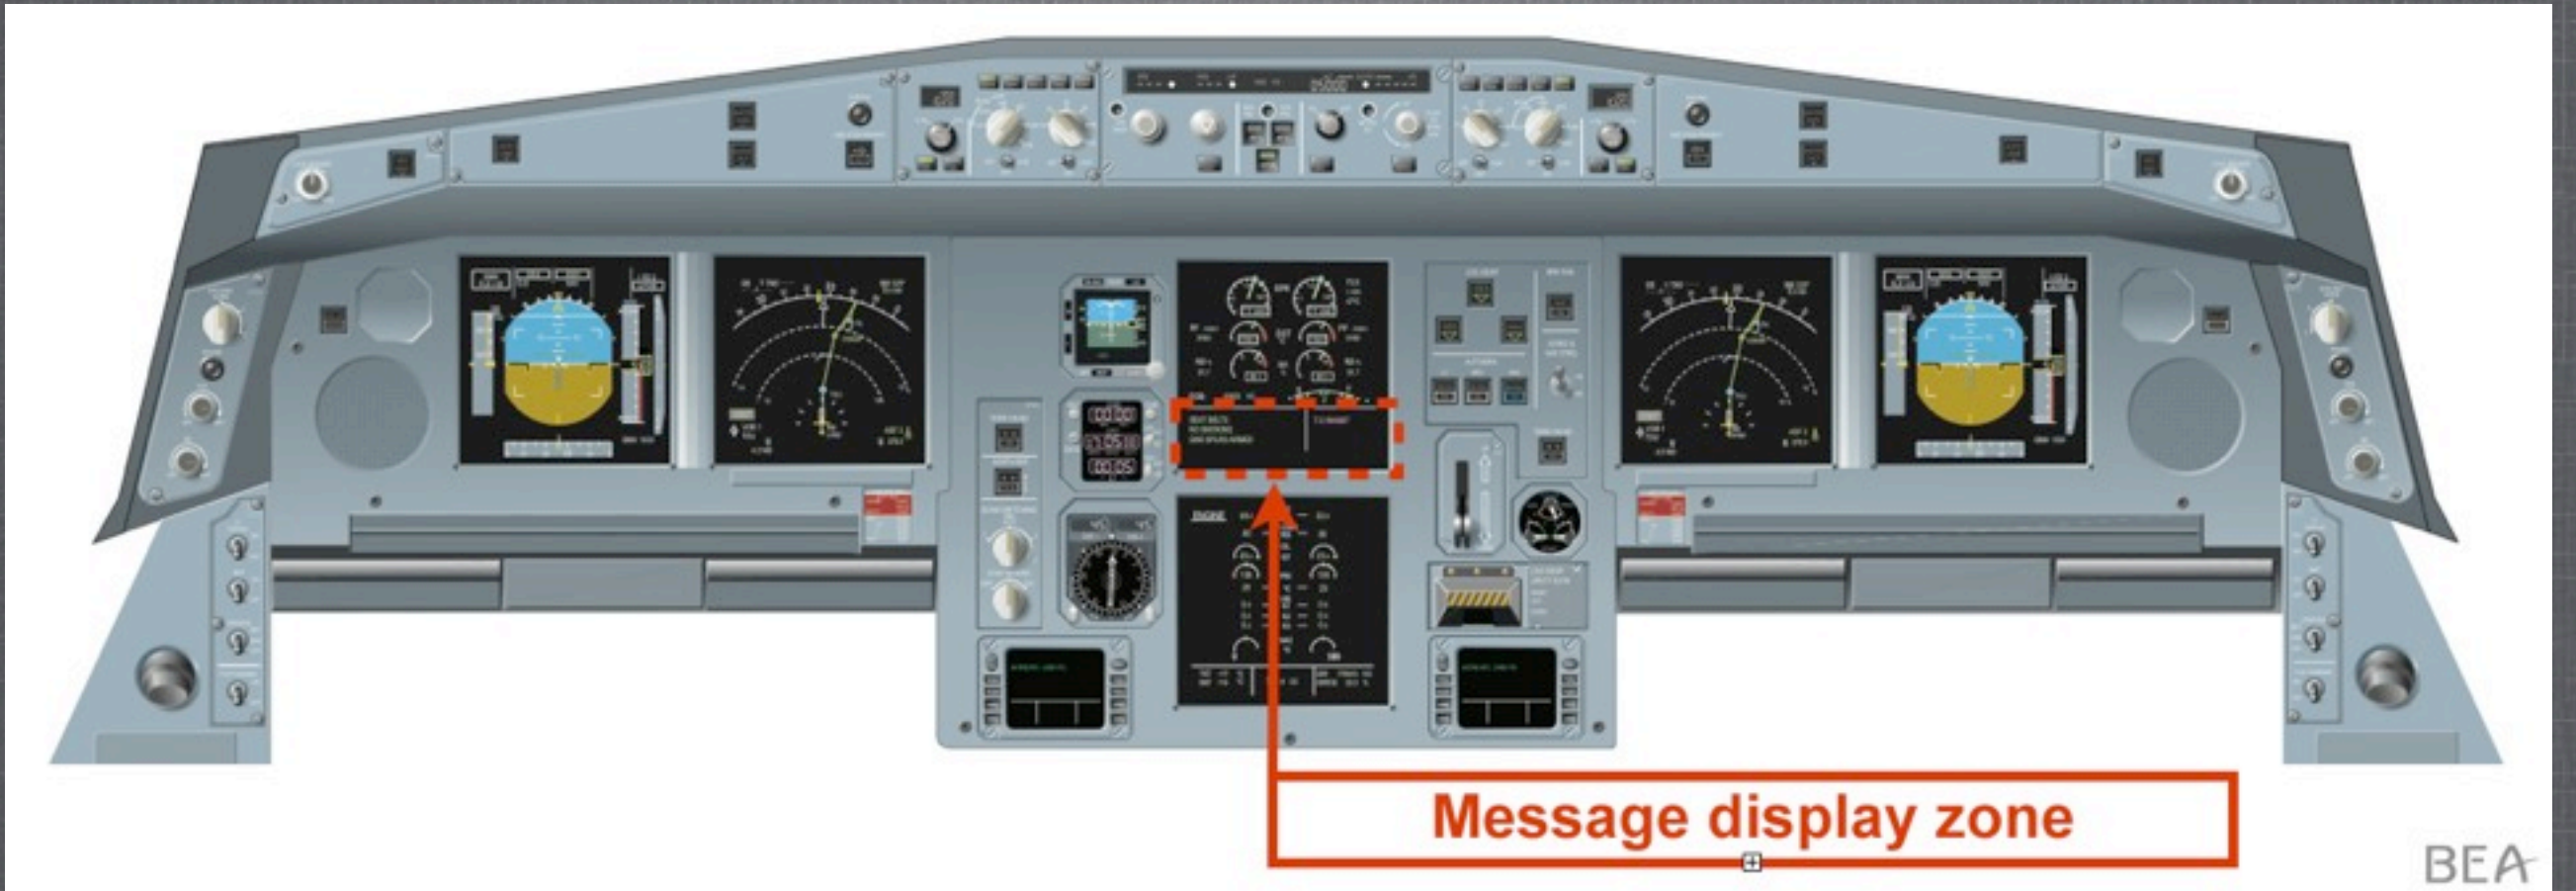
ECAM=Electronic Centralized Aircraft Monitoring  
Read across left to right, times a top  
AP OFF is first message T-emergency for pilots = 2:10:05  
Autopilot off – control required manual pilot control

ACARS Messages sent from Flight computer to Paris  
are displayed here (2:10:05)

24 Messages were displayed as sent, to inform ops center and pilots of faults  
Pilots have to observe, diagnose and respond to displayed messages, sounds and voiced stall  
warnings while managing aircraft flight at night in rough weather with no external visual  
navigation cues

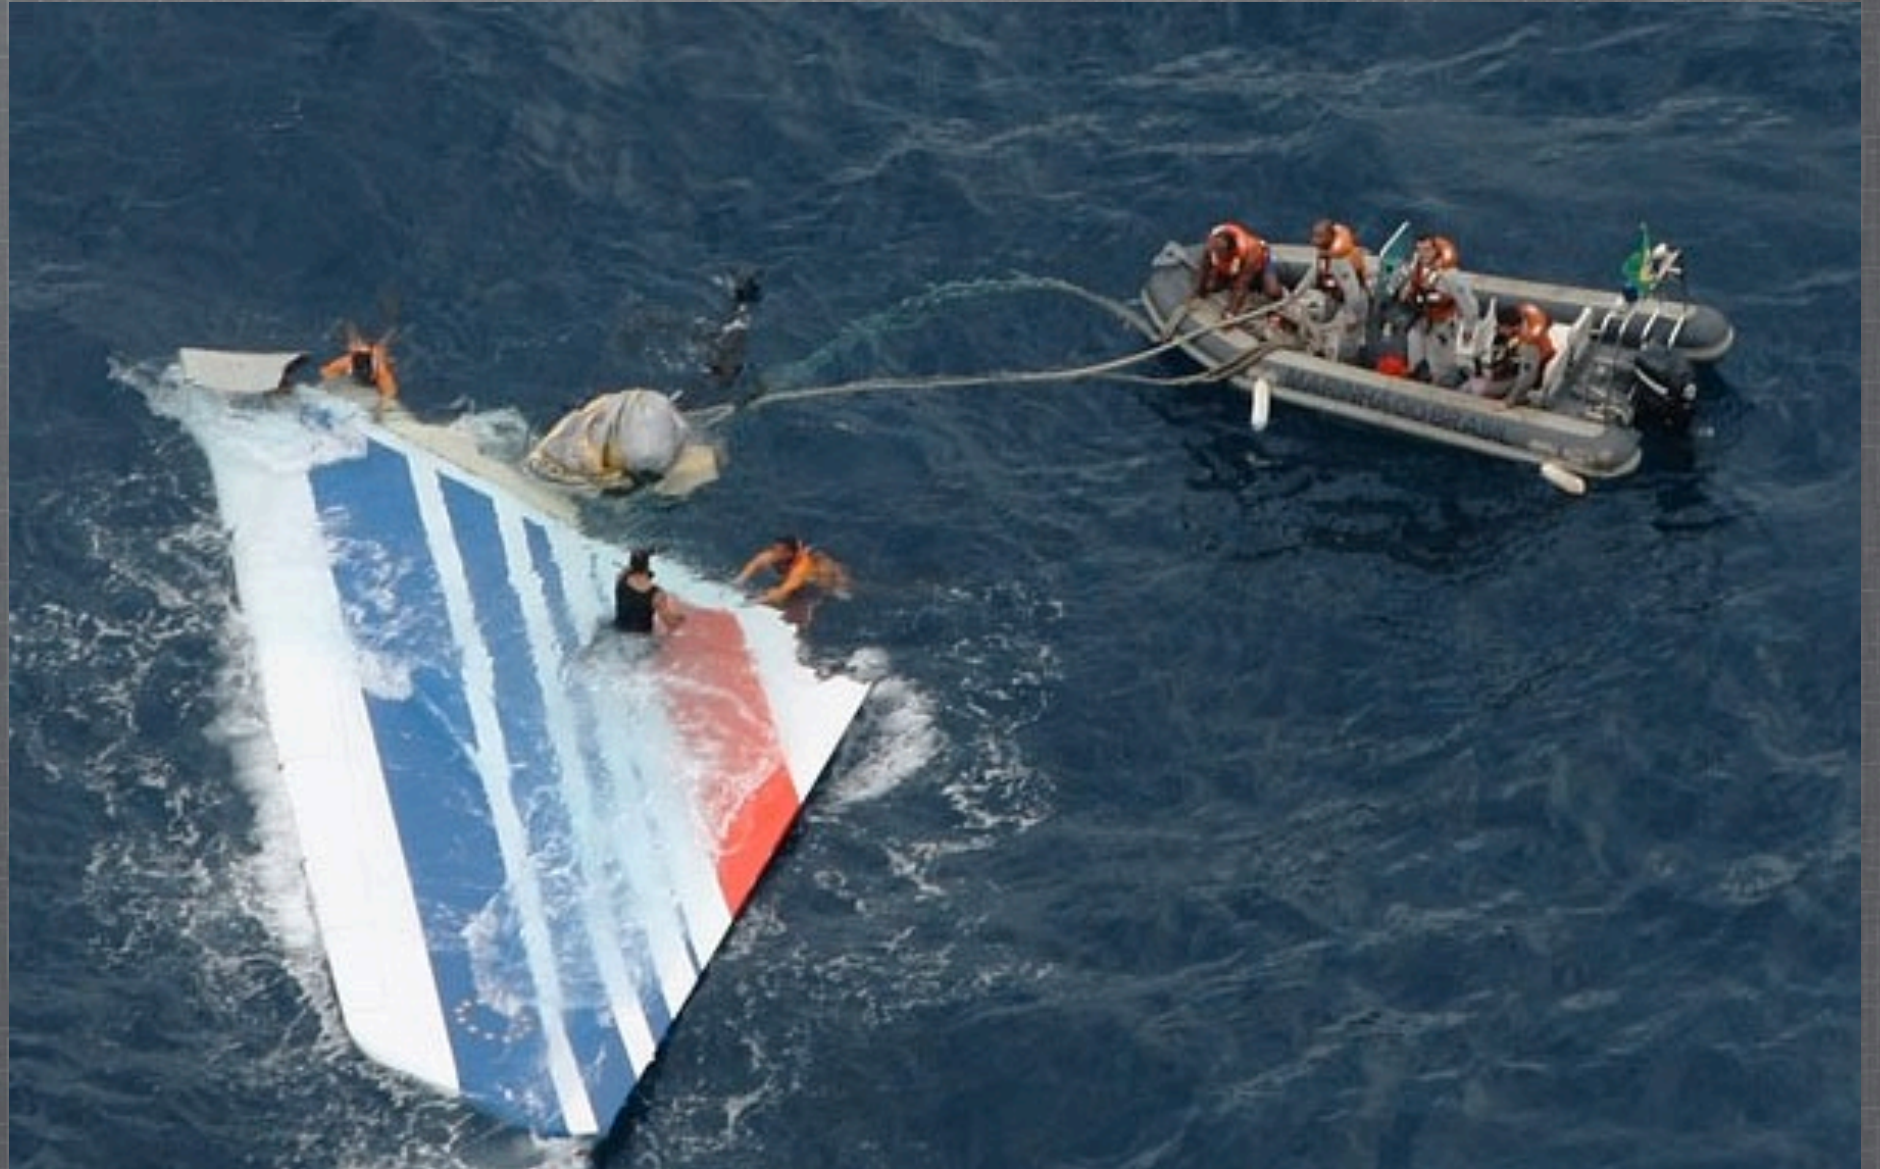
Surface debris indicated 447 was intact on impact

Tail section here was largest piece of floating debris. A handful of other floating parts were also recovered.

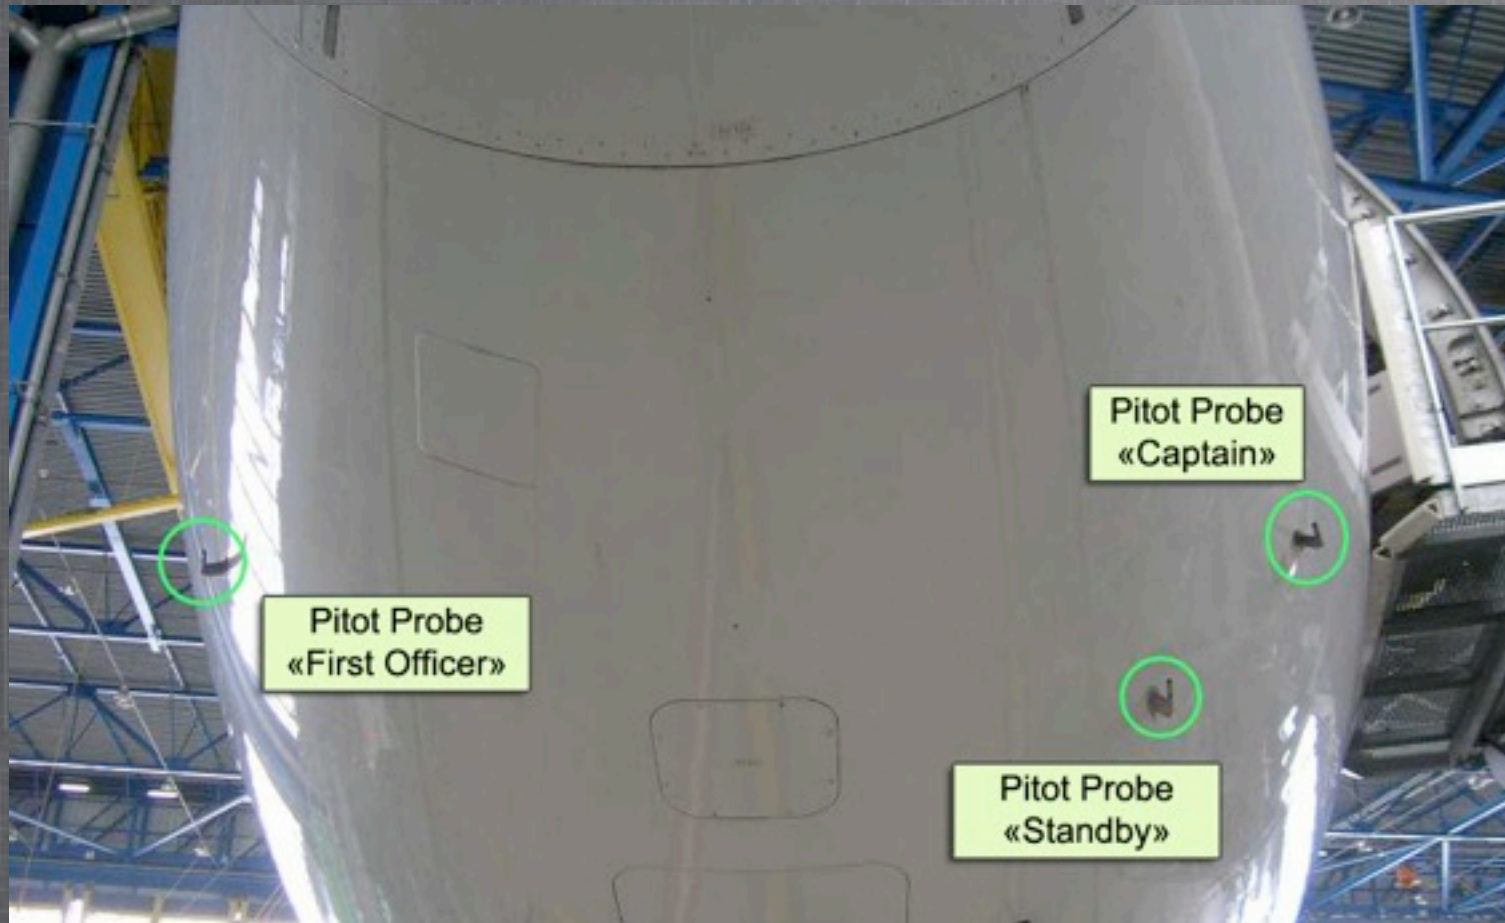
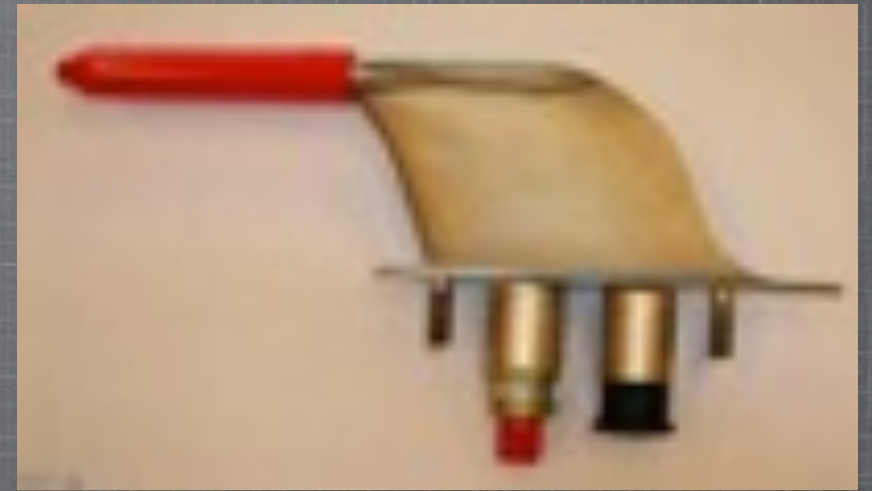
# Investigation keyed on ACARS reports, suggesting pitot tube ice blockage

## Computer programmed to reject odd inputs

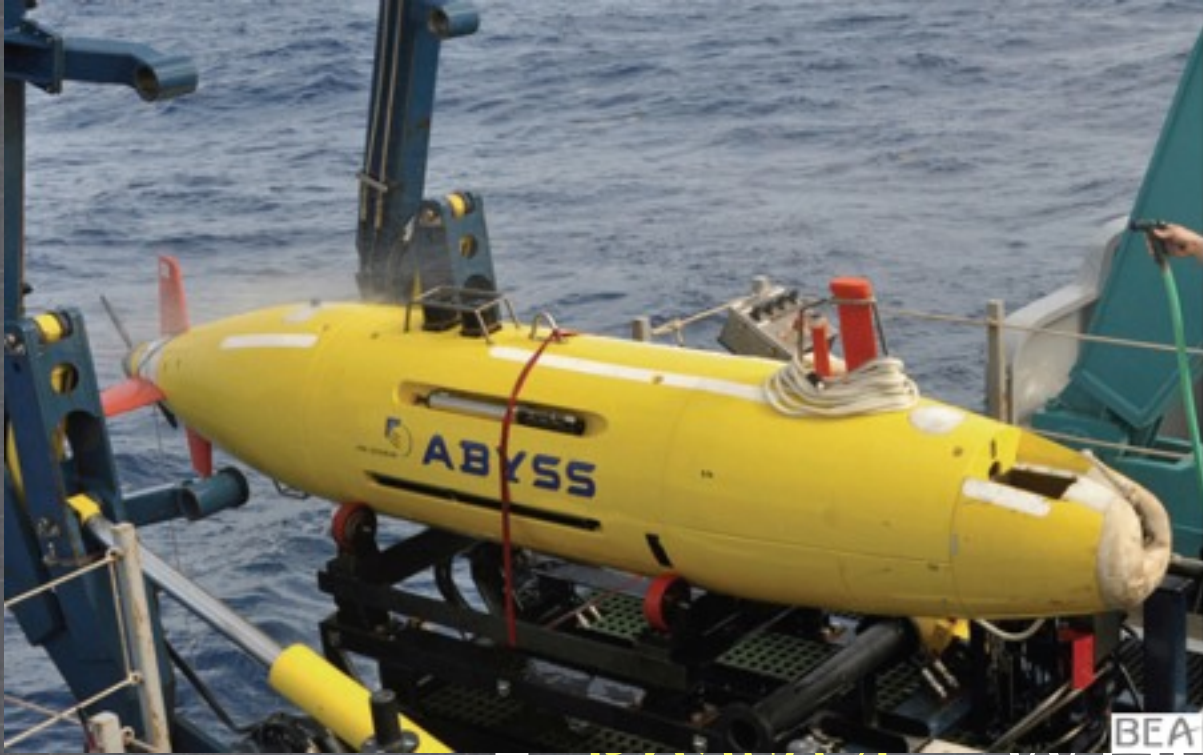
# The Investigation

- Phase 4 = WHOI operated terrain-following AUVs
  - site discovered at 3900 m depth, 6.5 nm NNE of last position transmitted by 447
  - photo runs
  - photo fusion

Woods Hole Ocean Institute vessel operating AUVs using sonar runs over the most likely location finally discovered the site 6.5 nm from last 447 position sent from the airplane. Lots of runs.
