# **Air France Flight AF 447**

over the Atlantic ocean on June 1, 2009

Based on France's BEA's Final Report of this accident,  
with my personal observations and comments.

OLLI Course T 802

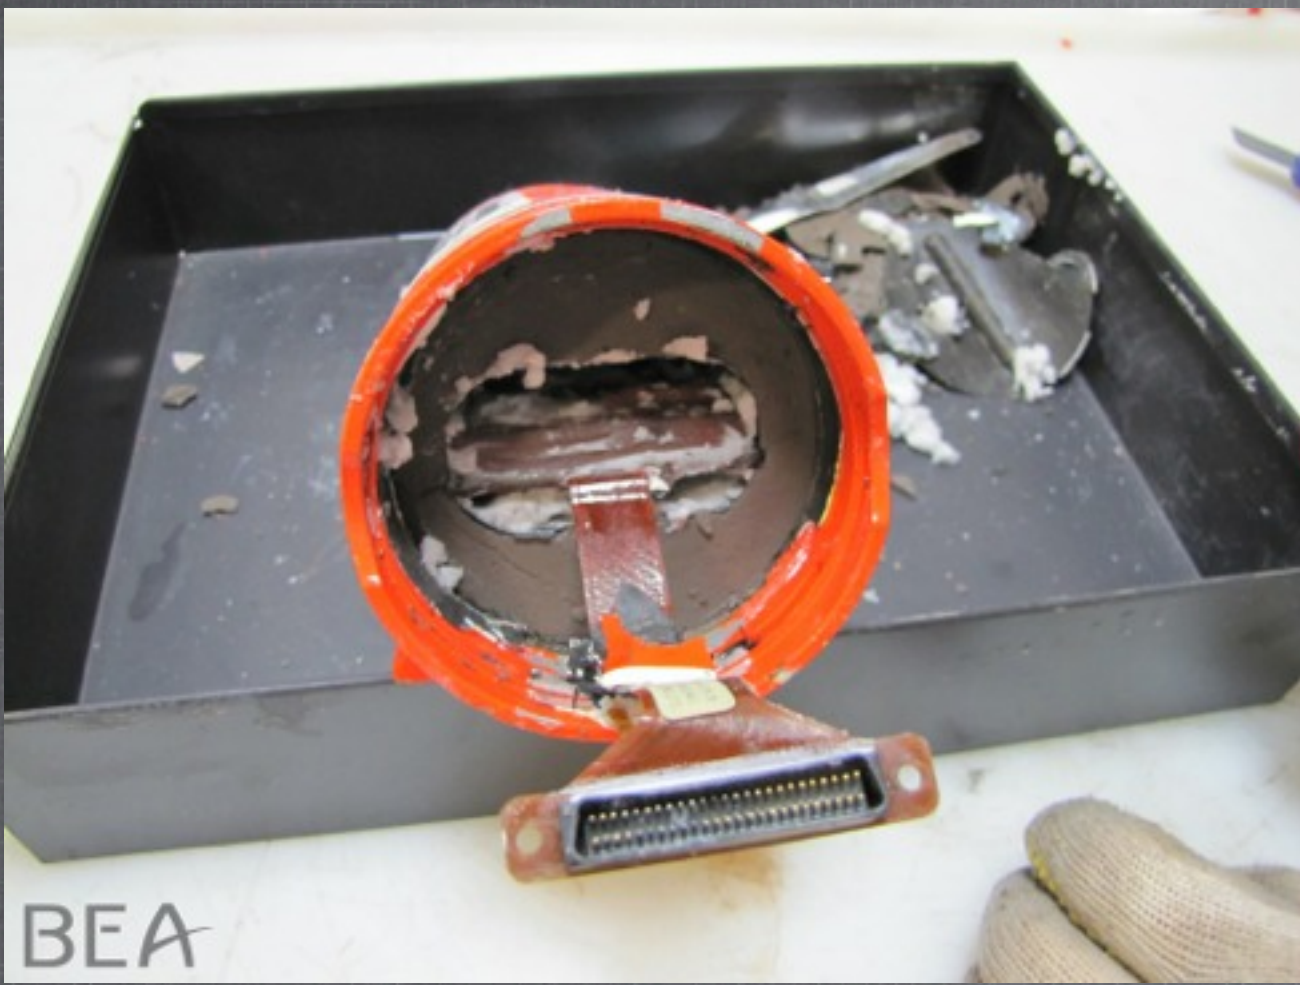
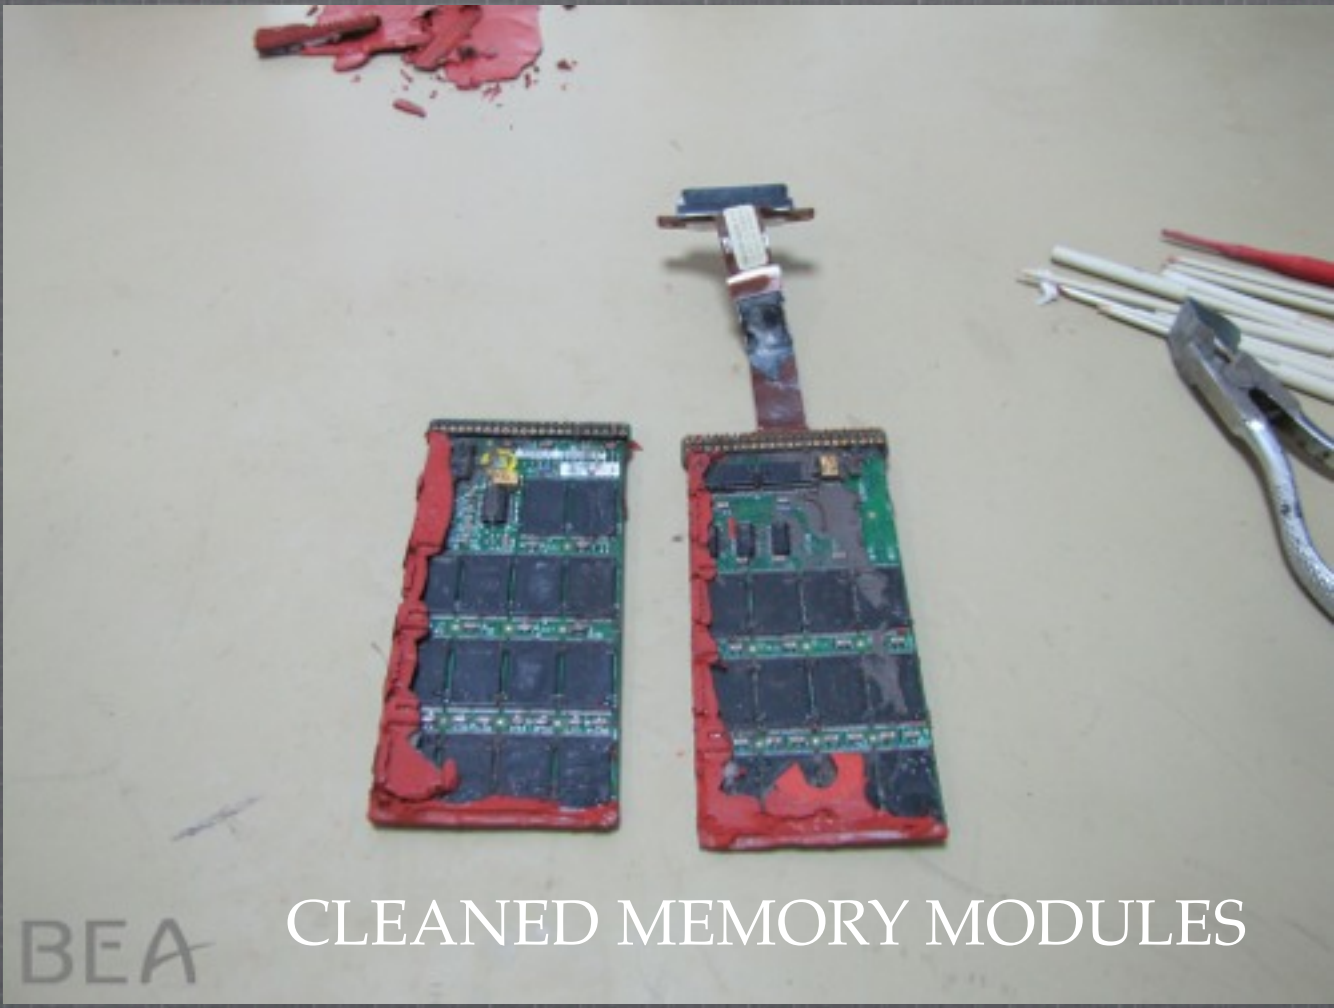
CVR

FDR

CLEANED MEMORY MODULES

Opened CVR and FDR modules after recovery after almost 2 years underwater. Handling them produces some VERY ANXIOUS MOMENTS!!

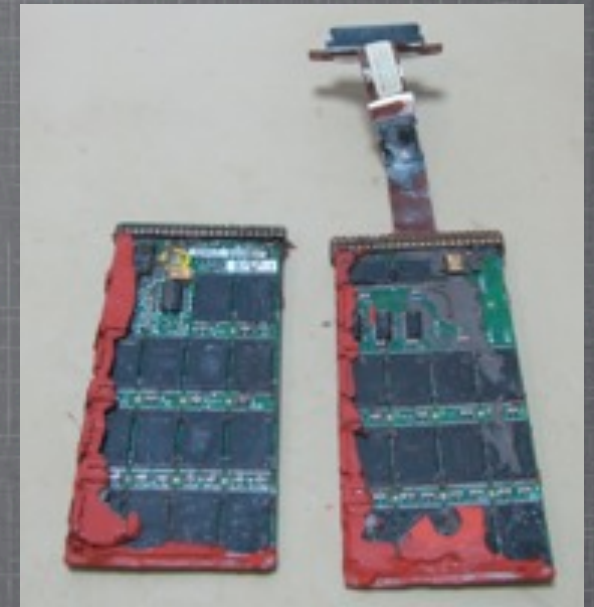
⑧ Track 1: radio communications and the signal from the microphones for the pilot seated on the left;  
⑧⑧ Track 2: radio communications and the signal from the microphones for the pilot seated on the right;  
⑧⑧ Track 3: radio communications, the signal from the second copilot's microphone (rear seat), and the FSK signal;  
⑧⑧ A track made up from the first 3 tracks mixed together;  
⑧⑧ CAM track: the signal from the cockpit area microphone.  
Sync'd to 100 ms accuracy

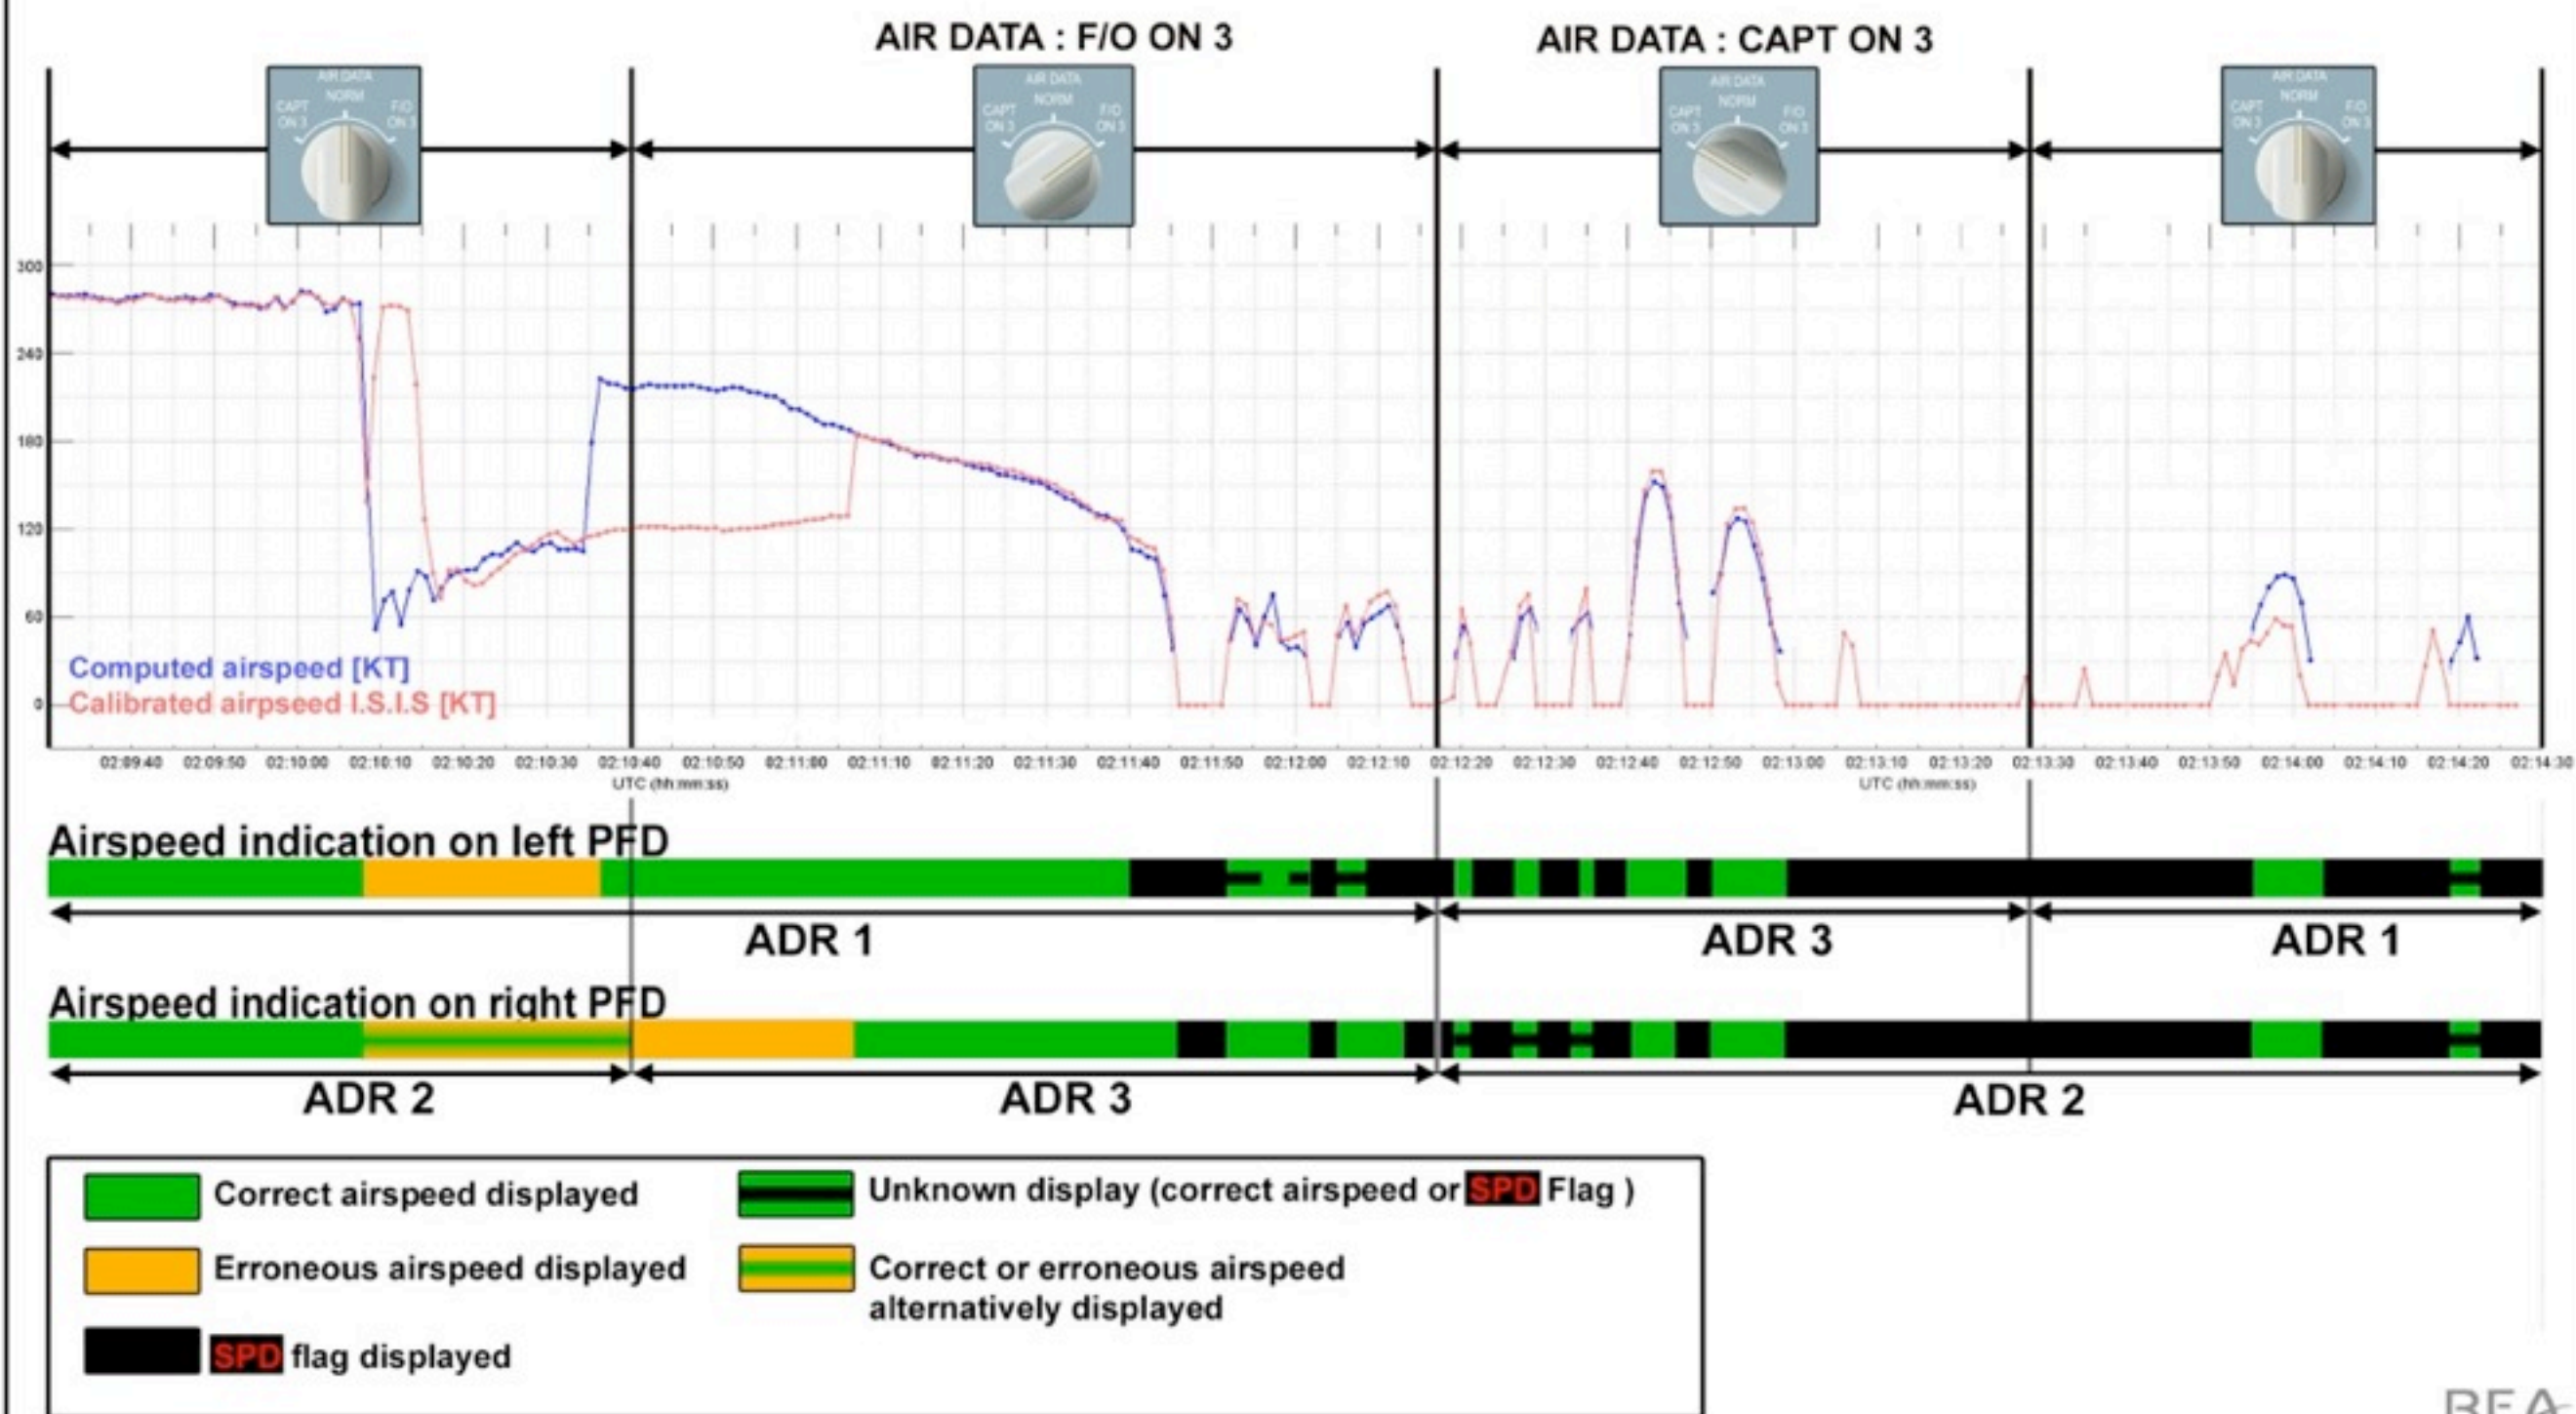
# Airspeed indication displayed on left and right PFD (Evaluated from FDR data)

Note orange and black parts of bars during the crucial 4 minutes pilots were trying to figure out what was happening...

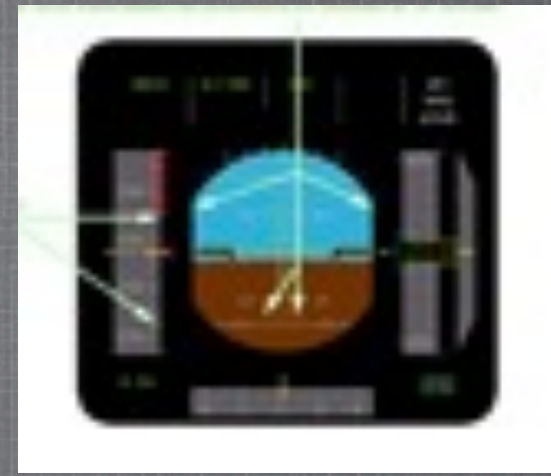
## Angle of Attack Measurement

To EASA and FAA

1. evaluate the relevance of requiring presence of an angle of attack indicator directly accessible to pilots onboard airplanes
